# Why remove the Science Wing (built last 1995)

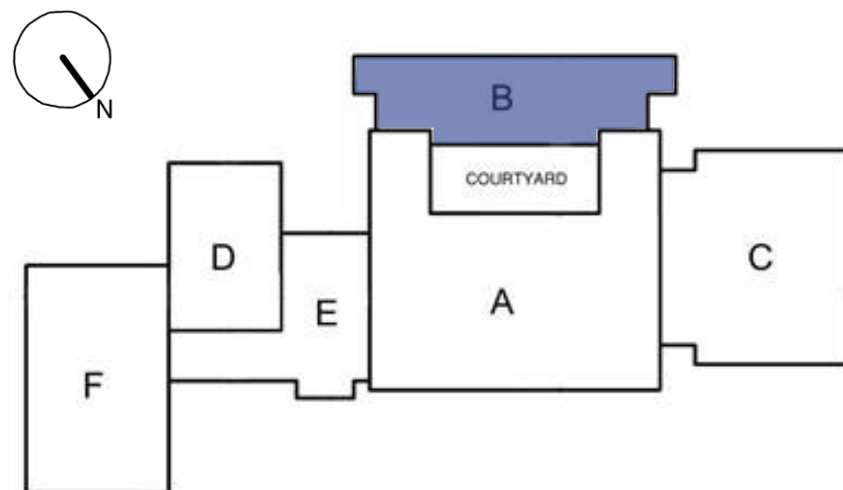
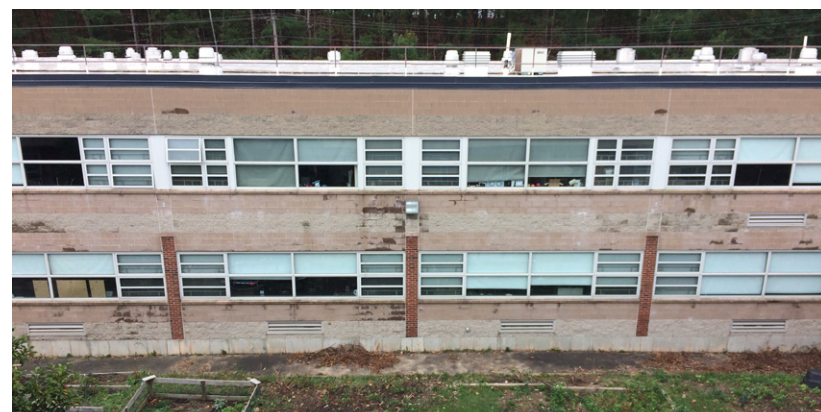
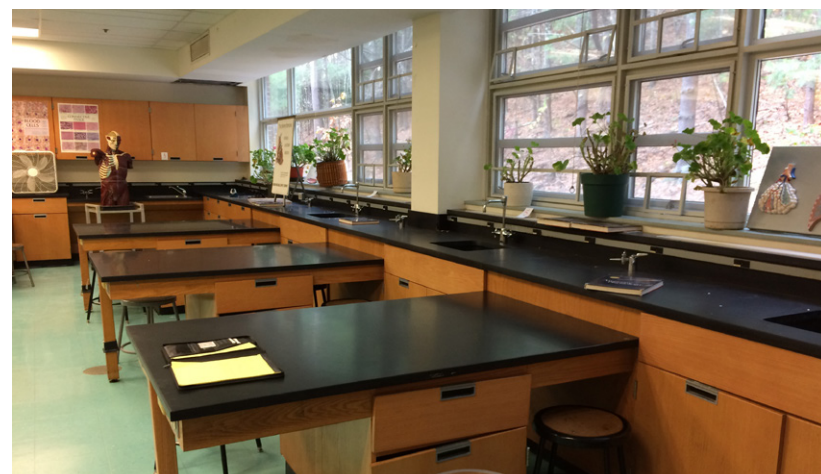
- Poor location at the back southwest corner of the site, up against the hillside, resulting in security and circulation challenges

- Exterior walls need repair, powerwashing, waterproofing, seal masonry and add expansion joint, and has constricted access to the outdoor courtyard
- Exterior walls and roof require thermal envelope upgrades for 2021 Code compliance

- Inaccessible lab-classrooms - replace all built-in casework, furniture and equipment
- All spaces are undersized and do not meet MSBA standards
- Corroding piping and leaks throughout the Science wing.
- Replace all science room fixtures and provide non-potable water, tempered water to emergency showers.
- Inadequate indoor air-quality systems and temperature controls
